**SITE ASSESSMENT REPORT
FOR
PULLMAN/LIQUID DYNAMICS SITE
CHICAGO, COOK COUNTY, ILLINOIS
TDD: S05-9802-022
PAN: 8F2201SIXX**

April 7, 1998

**UNITED STATES ENVIRONMENTAL PROTECTION AGENCY
Emergency and Enforcement Response Branch
77 West Jackson Boulevard
Chicago, Illinois 60604**

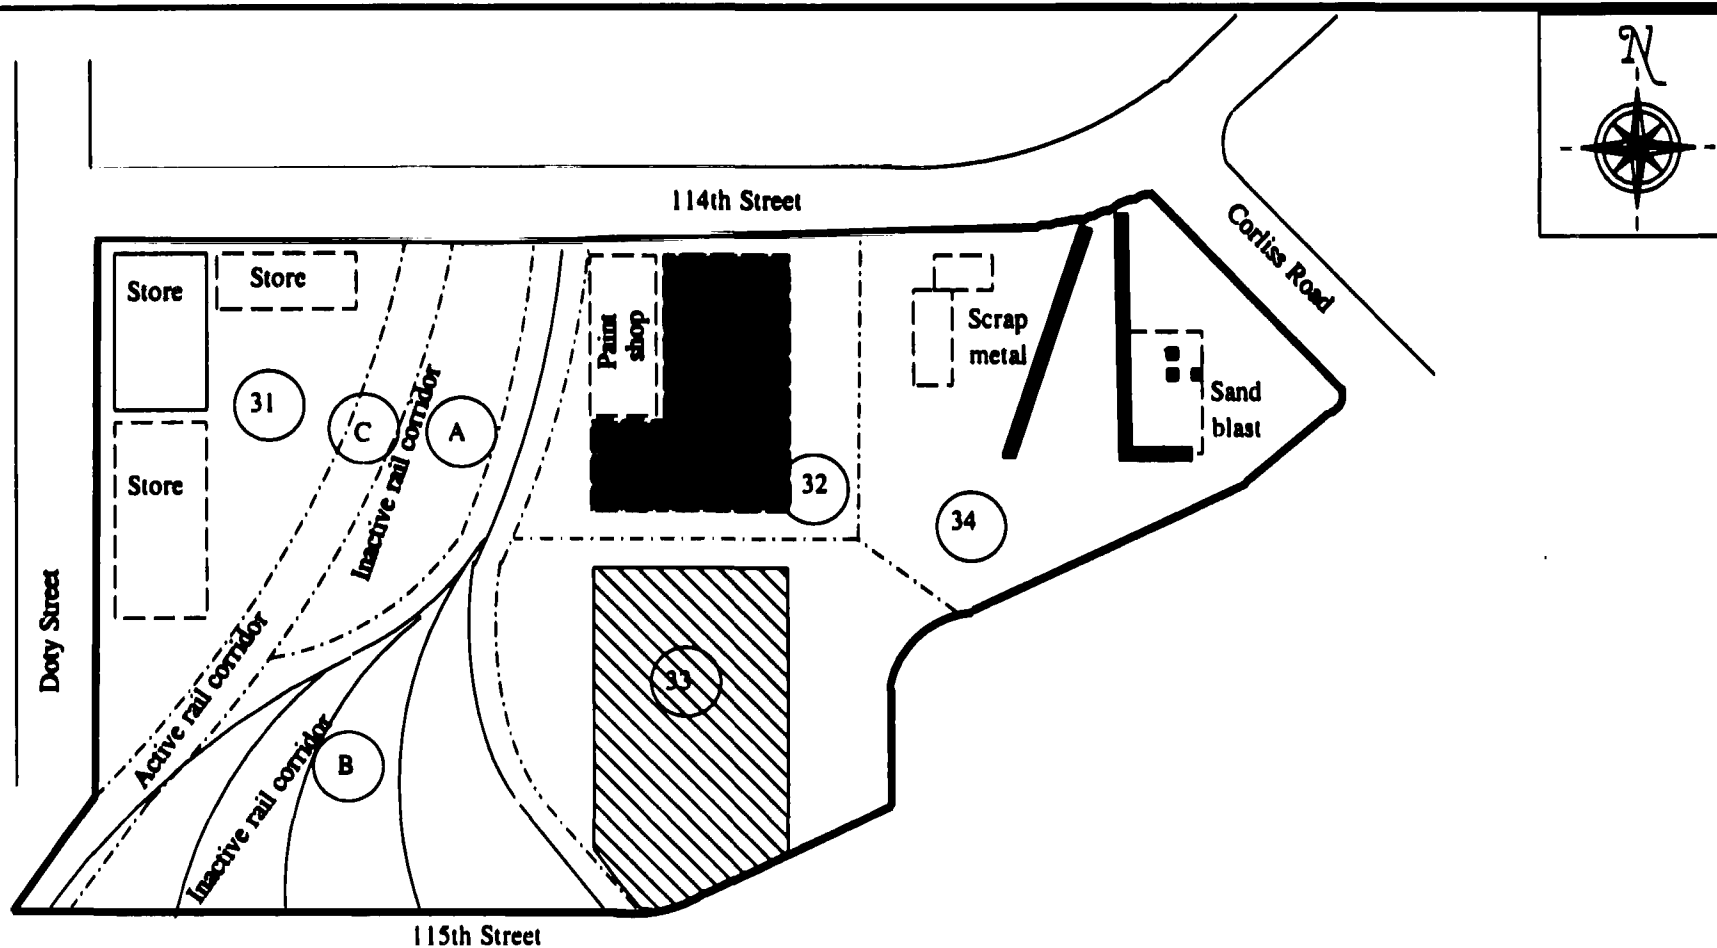
TITLE Site Features Map-Southern Lot		FIGURE 2-2
SITE Pullman/Liquid Dynamics		SCALE 1" = 200'
CITY Chicago	STATE Illinois	TDD S05-9711-007
SOURCE Ecology & Environment, Inc.		DATE December 1997

The southern lot comprises four parcels of land; 31, 32, 33, 34, and three outlots; A, B, C (Figure 2-2). The parcels and outlots are currently vacant, except outlot C, which is an active rail facility. The southern lot was once owned by the Pullman Palace Car Company.

Parcel 31, formerly owned and occupied by Liquid Dynamics, comprises 2.2 acres and is currently owned by Liacon, Incorporated. The concrete slab foundations of previously existing buildings cover approximately two-thirds of the parcel. The foundations appear to have no notable deterioration.

The remaining areas are generally covered by fill and gravel, with intermittent areas of short grasses. Trees border the parcel to the east, west, and south. The eastern portion of the parcel may have been filled with rock and gravel. Several open manholes and two empty rusted tanks were observed on the parcel.

Parcel 32 comprises 1.8 acres and is privately owned by an individual. The remnants of a cracked concrete slab foundation of a former building remain on site. The remaining portion of the parcel is generally covered by grass, although there are areas without vegetation. Random dumping has occurred on this parcel.

Parcels 33 and 34 are currently owned by Heritage Pullman Bank. The surface layer of the parcels is a mixture of sand, soil, cinders, brick, concrete, vegetation, and scrap steel. Parcel 33 comprises 2.4 acres. Trees border the parcel to the west and south. A grassy field, frequented by local children, is at the southern end of the parcel. Parcel 34 comprises approximately 2.6 acres. The parcel contains large areas surfaced with concrete. The concrete remains from former parking areas and slab foundations.

Outlot A is approximately 1 acre in size and is owned by Heritage Pullman Bank. Outlot A is well vegetated with grasses and trees. Outlot B is 2.4 acres in size and is owned by the Illinois Central Railroad. Outlot C is also owned by the Illinois Central Railroad and is part of an active railway corridor. Outlot C is approximately 0.8 acres in size.

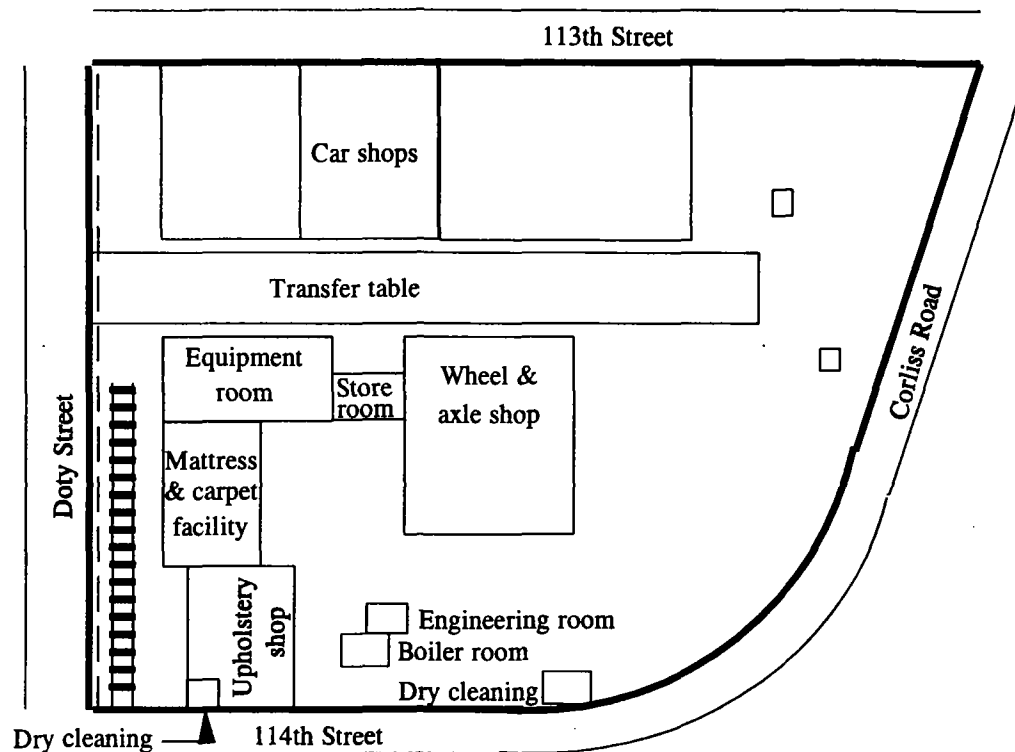
TITLE	Site Features Map-Northern Lot	FIGURE	2-3
SITE	Pullman/Liquid Dynamics	SCALE	1" = 200'
CITY	Chicago	STATE	Illinois
SOURCE	Ecology & Environment, Inc.	TDD	S05-9711-007
		DATE	December 1997

The northern lot is 9 acres in size and is privately owned (Figure 2-3). The northern lot is bordered to the west by railroad tracks. A fence separates the railroad tracks from the northern lot. No additional fencing is on the northern lot. The surface of the northern lot is comprised of overgrown vegetation, trees, remnants of structures, bare soil, rocks, cinders, brick, slag, and debris. Some pits which are filled with soil are located on the northern lot. Approximately two-thirds of the site consists of remnants of structures.

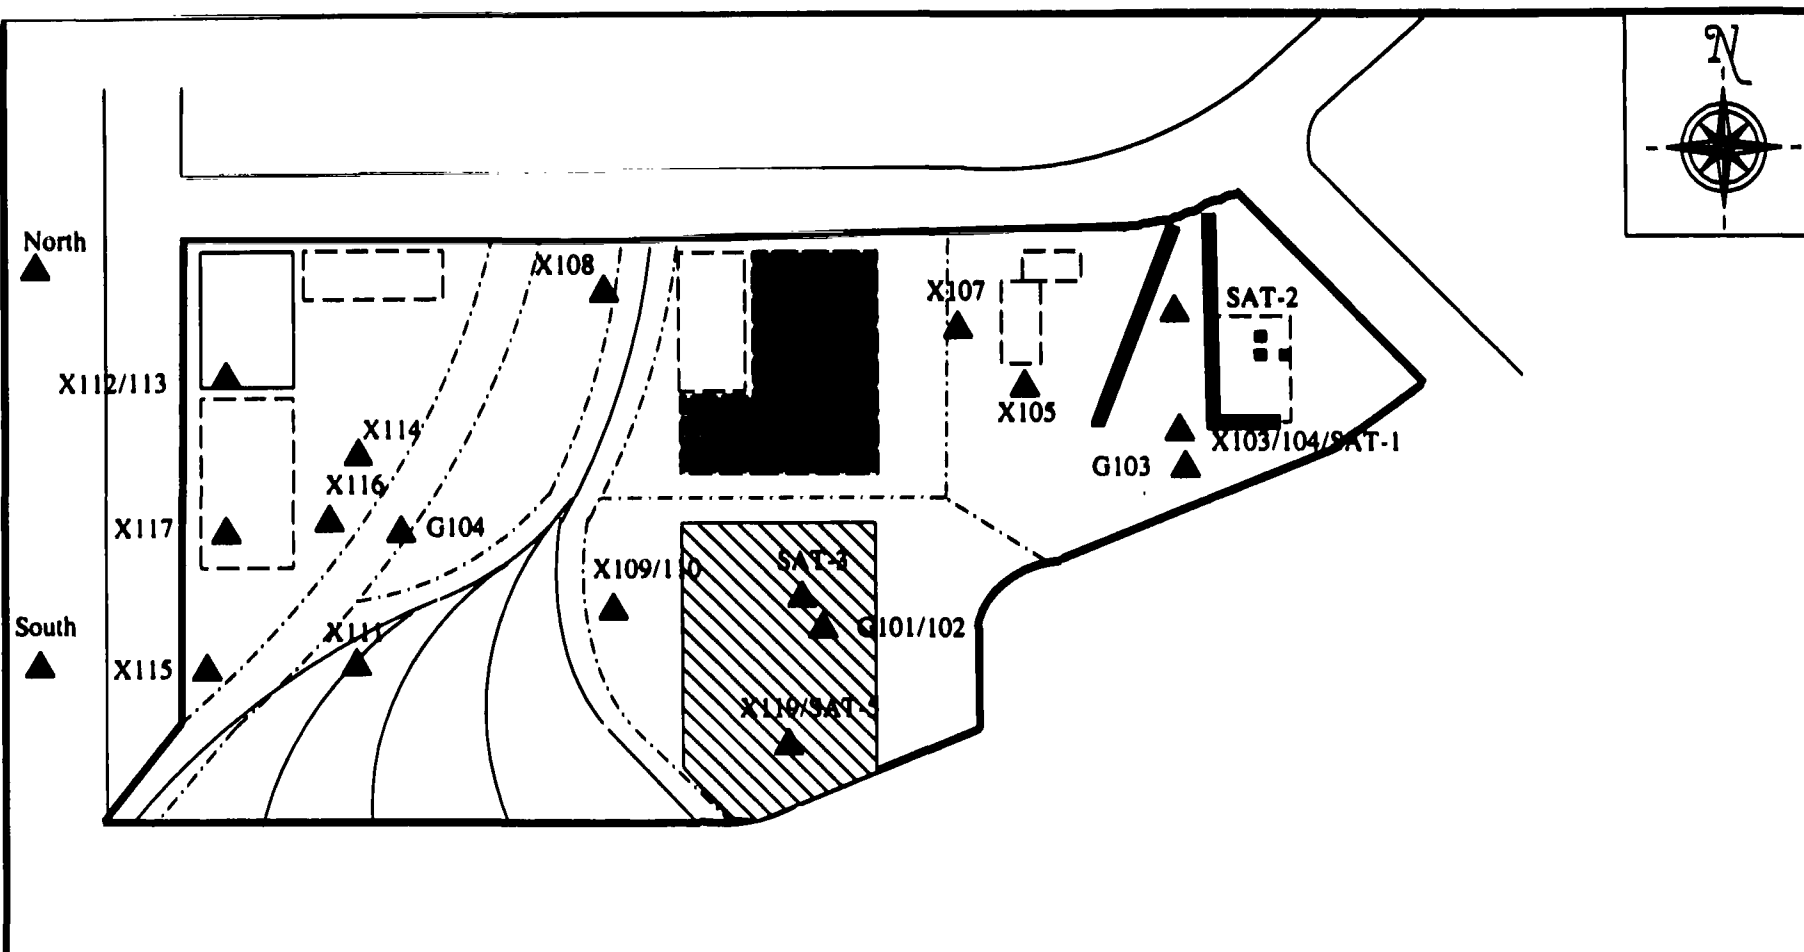
TITLE	Selected Historical Sampling Map-Southern Lot	FIGURE	2-4
SITE	Pullman/Liquid Dynamics	SCALE	1" = 200'
CITY	Chicago	STATE	Illinois
SOURCE	Ecology & Environment, Inc.	TDD	S05-9711-007
		DATE	December 1997

On August 1, 1997, a site assessment was conducted on Parcels 31, 32, 33, and 34 at the Pullman/Liquid Dynamics site by E & E START, under the authority of U.S. EPA. Six soil samples were collected and analyzed for RCRA metals (Table 2-8 and Figure 2-4).

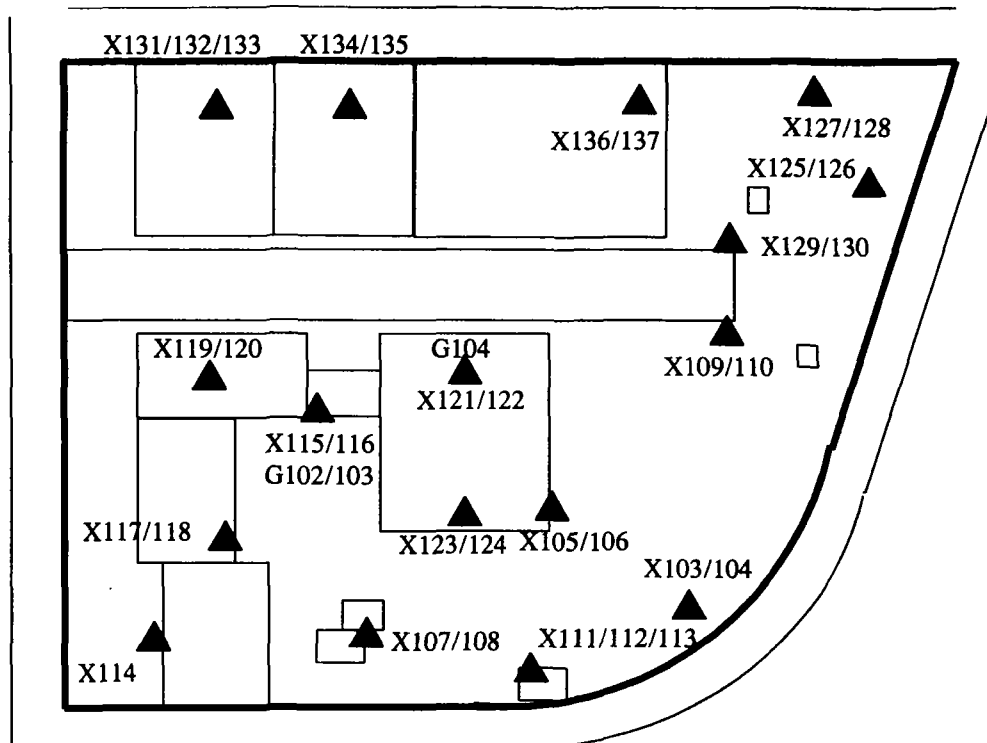
TITLE	Selected Historical Sampling Map-Northern Lot	FIGURE	2-5
SITE	Pullman/Liquid Dynamics	SCALE	1" = 200'
CITY	Chicago	STATE	Illinois
SOURCE	Ecology & Environment, Inc.	TDD	S05-9711-007
		DATE	December 1997

On July 16 and 17, 1997, IEPA collected 35 soil samples and four groundwater samples (Tables 2-9 through 2-14 and Figure 2-5). The soil samples were analyzed for selected volatiles, semivolatiles, pesticides, and inorganics. The groundwater samples were analyzed for selected semivolatiles, pesticides, and inorganics. Four of the soil samples were analyzed for TCLP inorganics.
